**DEPARTMENT OF TRANSPORTATION****DIVISION OF ENGINEERING SERVICES**

Contract #: 04-0120F4Cty: SF/ALA Rte: 80 PM: 13.2/13.9File #: 69.28**WELDING INSPECTION REPORT****Resident Engineer:**Pursell, Gary**Address:** 333 Burma Road**City:** Oakland, CA 94607**Report No:** WIR-002498**Date Inspected:** 06-May-2008**Project Name:** SAS Superstructure**OSM Arrival Time:** 1500**Prime Contractor:** American Bridge/Fluor Enterprises, a JV**OSM Departure Time:** 2200**Contractor:** Zhenhua Port Machinery Company, Ltd (ZPMC), Changxing Island **Location:** Shanghai, China**CWI Name:** Huang Wen Pang**CWI Present:** Yes No**Inspected CWI report:** Yes No N/A**Rod Oven in Use:** Yes No N/A**Electrode to specification:** Yes No N/A**Weld Procedures Followed:** Yes No N/A**Qualified Welders:** Yes No N/A**Verified Joint Fit-up:** Yes No N/A**Approved Drawings:** Yes No N/A**Approved WPS:** Yes No N/A**Delayed / Cancelled:** Yes No N/A**Bridge No:** 34-0006**Component:** Tower/OBG**Summary of Items Observed:**

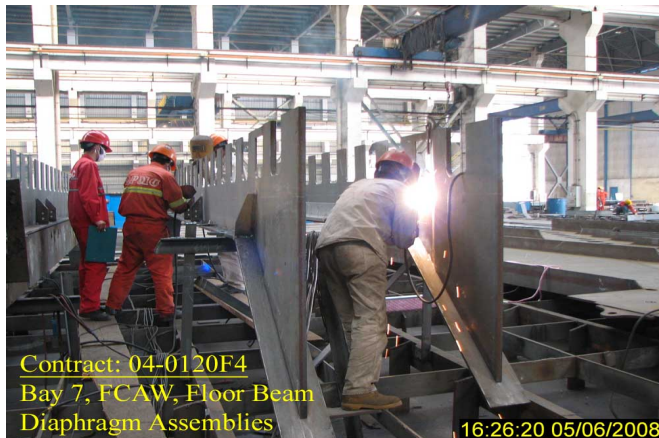
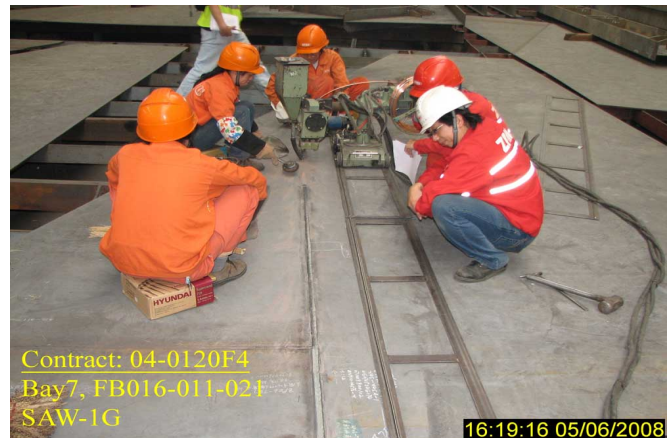
The following digital pictures below detail some of the work observed on this date.
